SERVICE BULLETIN SB0010

EFFECTIVE DATE:	THIS SERVICE BULLETIN IS EFFECTIVE August 25, 2009		
SUBJECT:	Exhaust Shroud Clearance to Engine Frame		
MODELS AFFECTED:	CC18-180A SERIAL NUMBER 0001 CC18-180 SERIAL NUMBERS 0002 THROUGH 0035		
COMPLIANCE TIME:	AT THE NEXT M	AINTENANCE ACTION	
PURPOSE:	Cub Crafters, Inc. has had an instance of engine mount chaffing due to a hose clamp located on the exhaust shroud on the left rear side of the engine. Proper re-assembly and adjustment is required for installation. If clearance is unobtainable, a new revision of the exhaust shroud is available that provides more clearance. This Service Bulletin requires that the engine mount and exhaust shroud be inspected and addressed by adjustment or replacement if inadequate clearance exists.		
PARTS LIST:	<u>PART</u>	DESCRIPTION	QTY

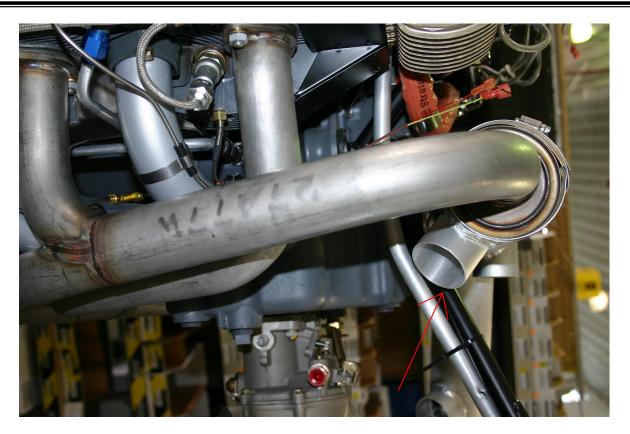
- 1. Open left side cowling and inspect the area near the cabin heat port on the exhaust shroud and the area of the engine frame for chaffing or damage. Removal of SCAT tubing and hose clamp may be required.
- If no damage or problems are noted, there is no further action required. As described in the Aircraft Maintenance Manual TC10000AMM Section 05-20, normal inspections should always include inspection for any damage to the exhaust shroud, system, or engine frame.
- 3. If less than .25" clearance between the exhaust shroud and the engine mount tube is noted, determine if adjustment can be made to increase the clearance. If you are unable to get adequate clearance or the shroud is damaged and in need of replacement, contact Cub Crafters for a replacement that provides for additional clearance in the area. If damage is noted to the engine frame, contact Cub Crafters.

FIGURE 1 – Left Side of Engine-Area in question at the mid-right side of photo, engine frame and exhaust shroud outlet

4. When reinstalling the heat shroud (as part of normal annual inspections, this heat shroud is to be removed and inspected as per the Aircraft Maintenance Manual TC10000AMM Section 05-20) care should be taken to locate the exhaust shroud in the proper left-right position and the proper rotational alignment to give as much clearance as possible with the cabin heat outlet and the engine frame. Slide the assembly left-right to center between the exhaust pipes, but also ensure the outlet has .25" or greater clearance to the engine tube.

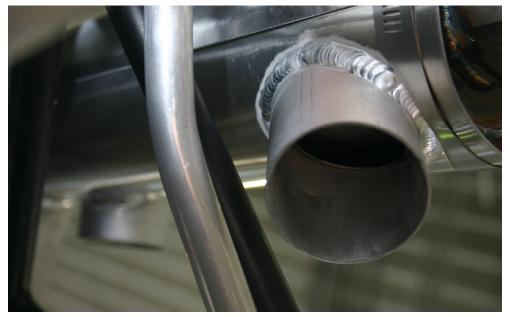
FIGURE 2 – Close View of Clearance Required

5. After installing the hose clamp over the SCAT tubing, ensure the adjustment portion of the hose clamp is not in close proximity to the engine frame.
